Water Resources Department

February 8, 2017

Re: 2016 Inspections of B Bar K Cascade Ranch Dams: Woodrat Knob (W-43); Lake Creek (L-24); Osborne (O-15) Bradshaw 1 and 2 (B-24, B-83), Frog Pond (F-30), Harrison (H-47)

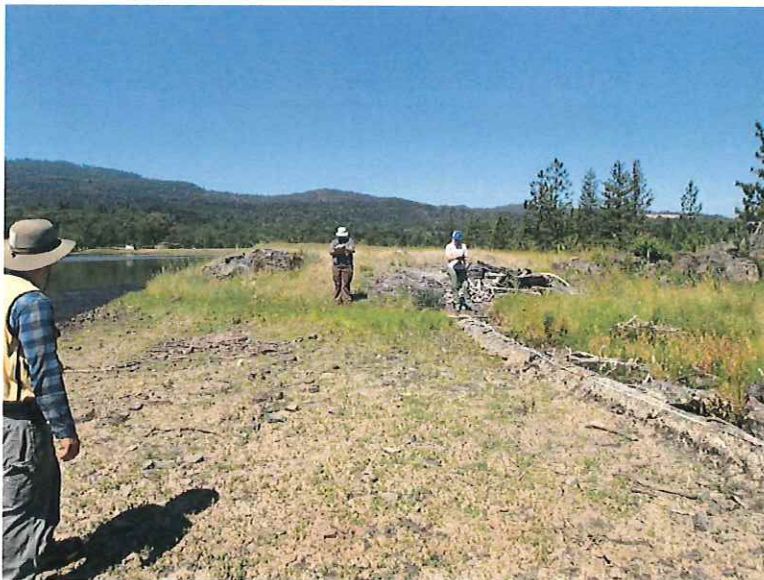
Spillway control section with reservoir in background

The reservoir level was 9.2 feet below the dam crest when inspected. Minimum freeboard was 4.2 feet. Based on measurements and analysis, the spillway capacity appears sufficient to pass an extreme flood. The reservoir was clean.

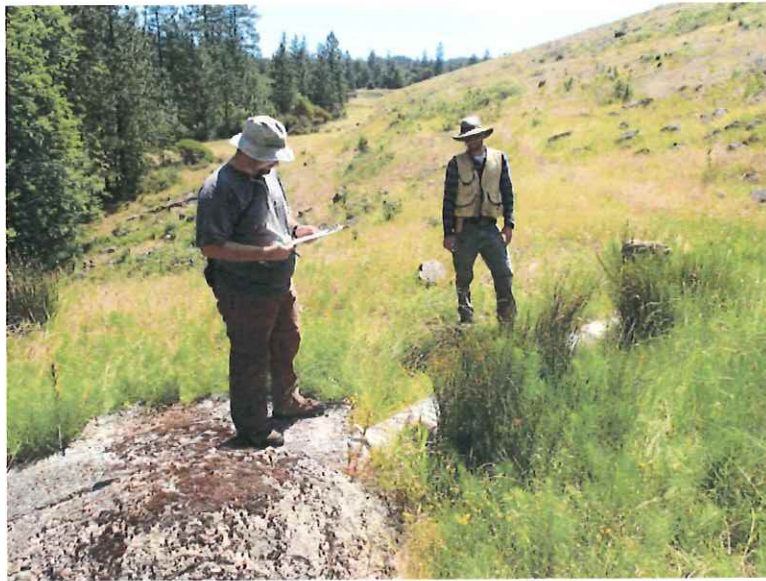
Low level conduit is deteriorated

The corrugated metal culvert that serves as the low level conduit through this dam continues to deteriorate slowly. The holes are slightly larger, and there is also a cut in the pipe from we believe an engineers' attempt to evaluate the conduit with a remote camera. If the valve is completely open, it is very likely to leak significantly from these locations, and cause erosion of the embankment and native materials in this general location.

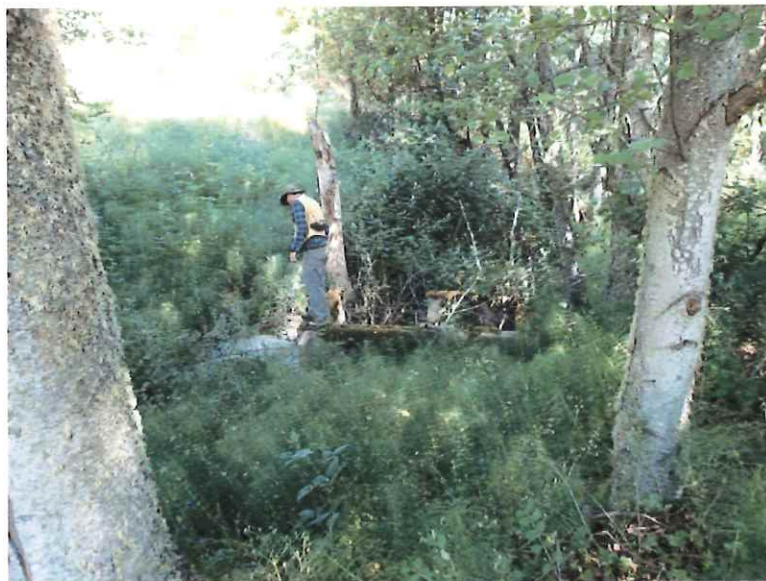
Outlet structure disconnected

The outlet works structure is heavily overgrown, and generally disconnected from the outlet pipe. The ground in this area is always wet and poorly drained, as evidenced by the

foxtail plants that are growing all around it. The trees (red alders) are also causing damage to the outlet structure.

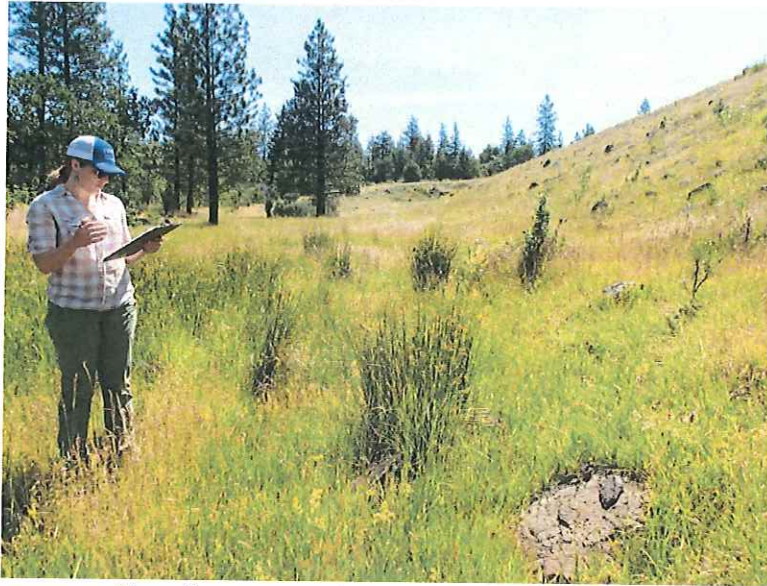
Excellent vegetation cover, some seepage

Both the upstream and downstream faces have a well maintained cover of grass, with very little woody vegetation. The only sign of seepage was in a few areas around the toe, with no observed leakage through the dam. We saw no sign of significant settlement or other indications of embankment instability.

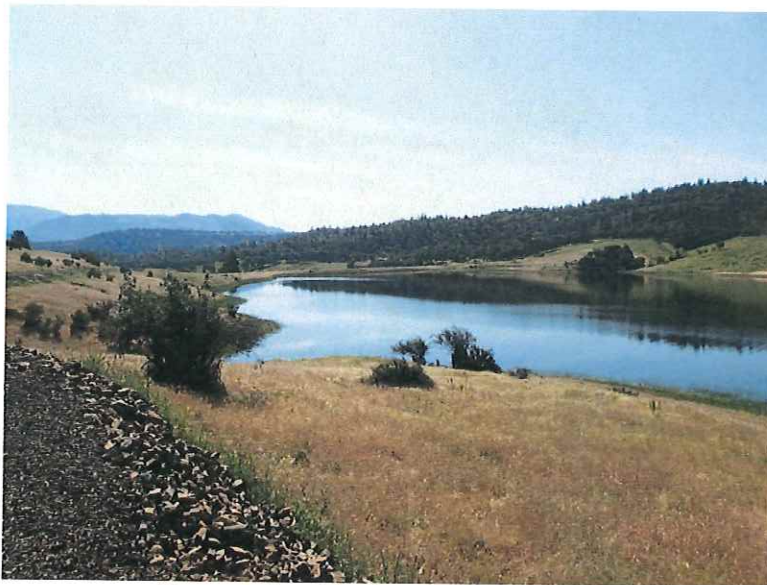
Reservoir with dam in background

The reservoir level was 9.5 feet below the dam crest when inspected. Minimum freeboard was 6.3 feet, which is excellent. The reservoir was clean, with no logs or debris near the

dam. Both the up and downstream faces have a well maintained grass cover. The access and security at the dam are both good.

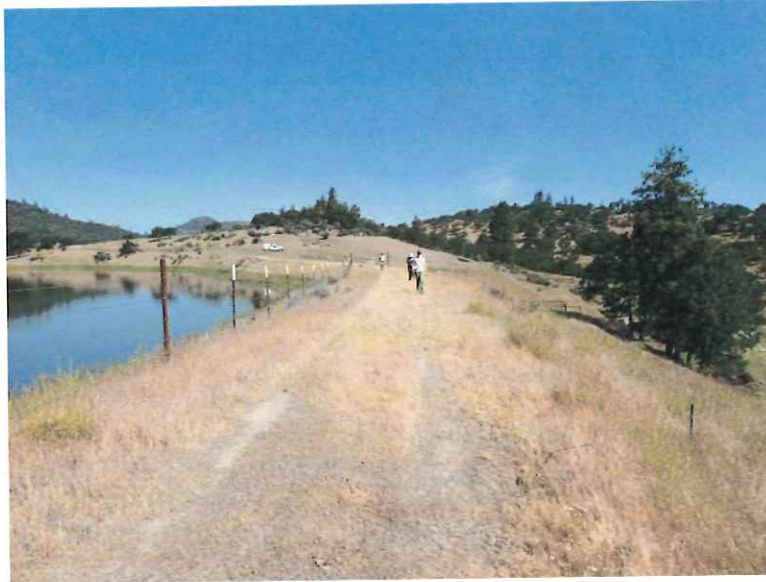
Crest of dam

The crest of the dam shows no sign of instability. There is no sign of reactivation of movement that caused a near failure of this dam in 1961. However, we have no information on water pressures inside the dam, as the piezometers (one shown on the downstream face in the photo above) have long been out of service.

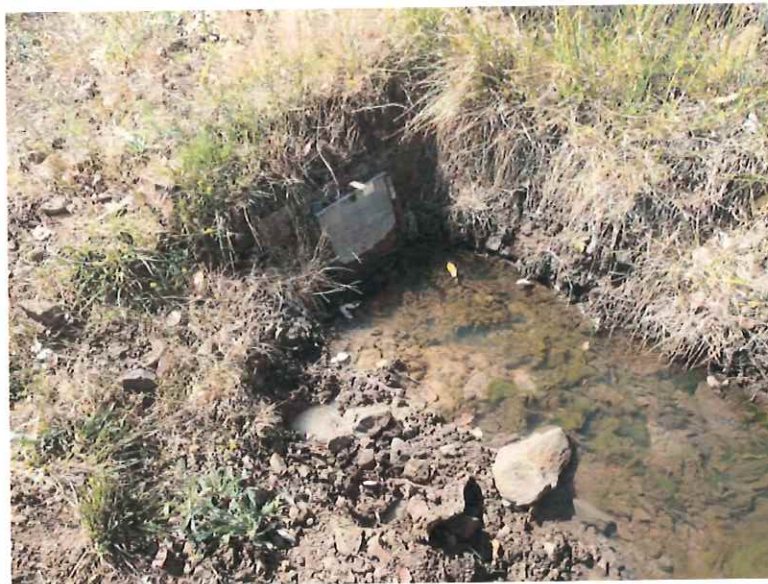
Outlet of conduit

This dam has no low level outlet, probably because of the aforementioned near failure. This 18 inch culvert was placed at mid-elevation after that near failure. The culvert has deteriorated badly, and has reached the point where action is necessary to prevent this from becoming an unsafe condition. This culvert should be inspected if possible and either replaced, or if safe, relined.

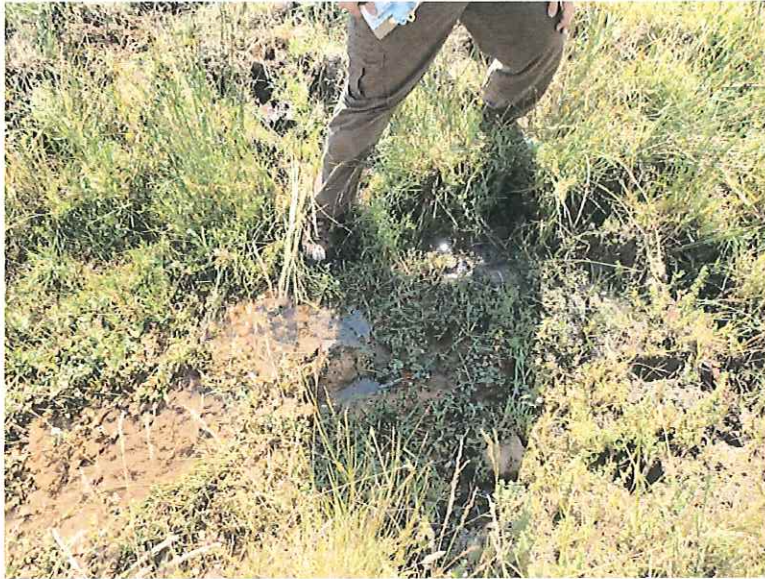
Seepage from failed drains

The seepage is caused by blockages and failure of the culverts installed in the early 60's to stabilize the dam after the major landslide. New drain pipes are necessary to ensure the stability of the berm and its ability to keep the dam stable. These drains are believed critical, as they reduce water pressures within the dam. Excess water pressure from water seeping through the dam likely caused the large failure in 1961.

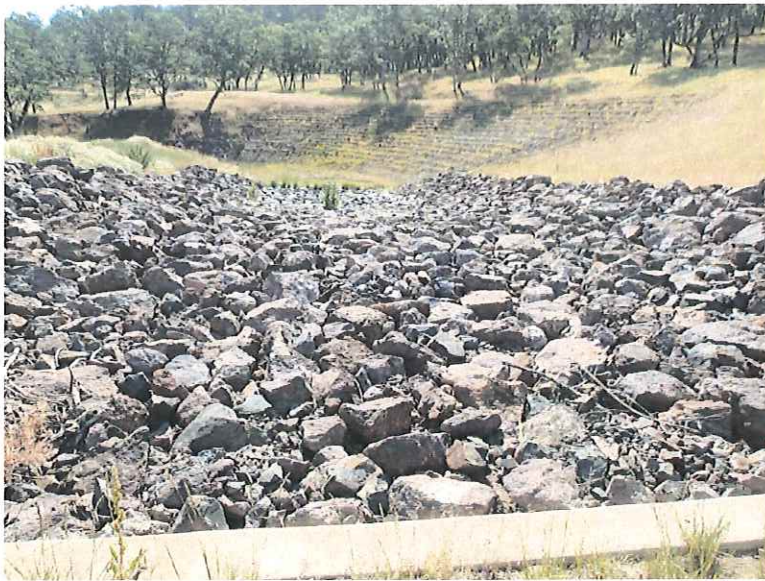
New spillway

The new spillway had flow for the first time in the winter and early spring of 2016. The spillway handled these flows with no erosion at all. This structure has greatly improved the safety of Woodrat Knob dam, at least in eliminating the potential of an overtopping failure due to a flood.

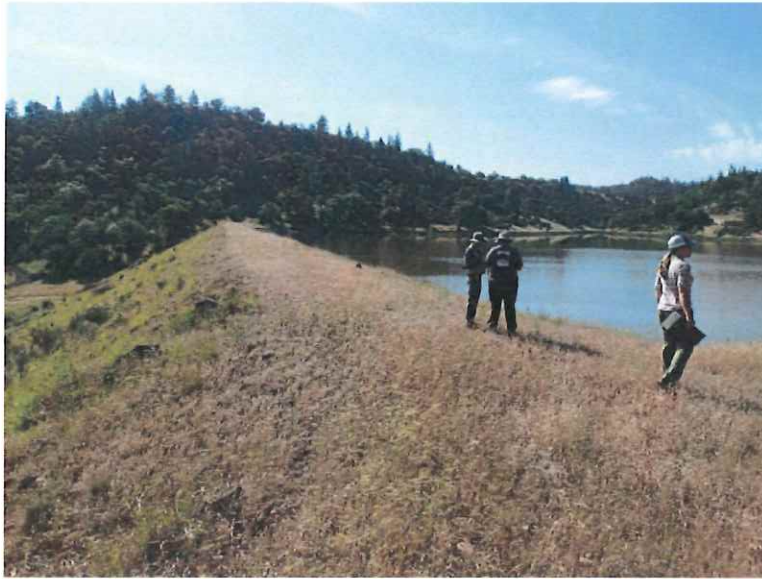
Reservoir and crest of dam

The reservoir level was 10.2 feet below the dam crest when inspected. Minimum freeboard was 4.5 feet, which is adequate. There is a little more woody vegetation on Osborne dam than on the other two dams inspected during this trip. The crest and embankment appear stable.

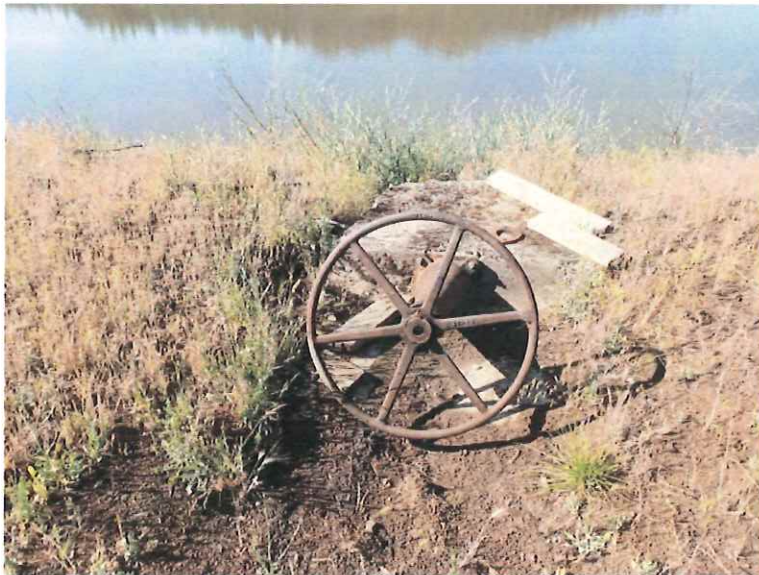
Valve was cycled

The control was operated for the first time in the last 5 years. It is nearly past its useful life. You will need an alternative that will be essential for draining water from the dam, both for maintenance, and in the event of an emergency. It may also be possible to construct a new outlet that is more conducive to your irrigation operations.

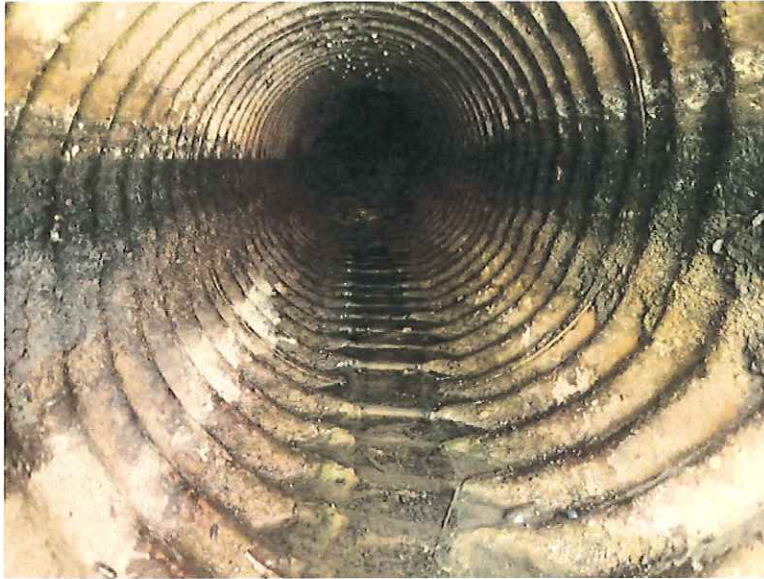
Inside of conduit

The inside of the outlet culvert is corroded, but we did not observe holes in the structure yet. This pipe will continue to deteriorate, and will become unsafe at some point in the not too distant future. On a positive note, you were able to operate the valve this year, and determine that both the valve and conduit are operational right now.

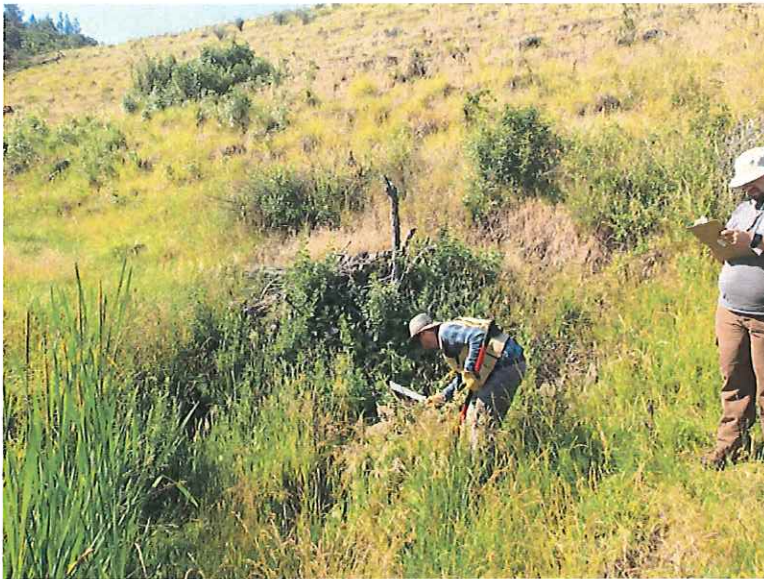
Brush regrowth around outlet

There is brush at the toe of the dam and there is seepage. The seepage is not collected, so it is not possible to determine if the rate of seepage is changing. The rest of dam has mostly grass cover and nothing restricts inspection. We observed no signs of instability on this dam, at this time.

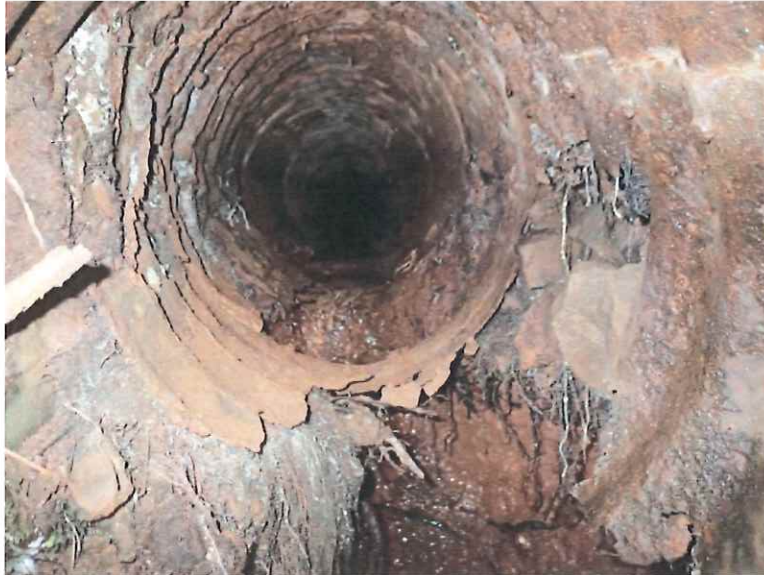
Deteriorated outlet conduit

There is water leaking from the low level outlet conduit. It is not clear if the leak is from within the conduit or from around the exterior of the conduit. The visible section of the corrugated metal pipe outlet is highly corroded and should be addressed.

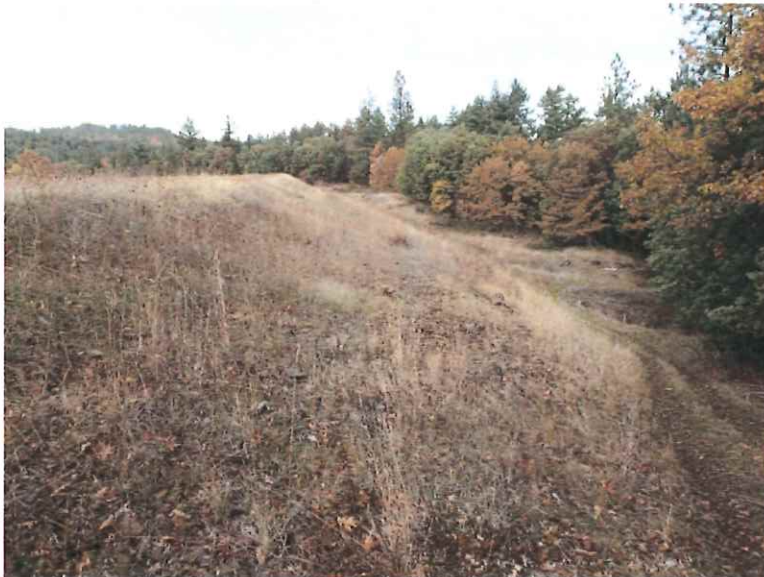
Main dam

The dam and auxiliary dam show signs of bovine activity. Cattle should be kept off these structures in order to preserve the integrity of the dam and its storage maximum capacity.

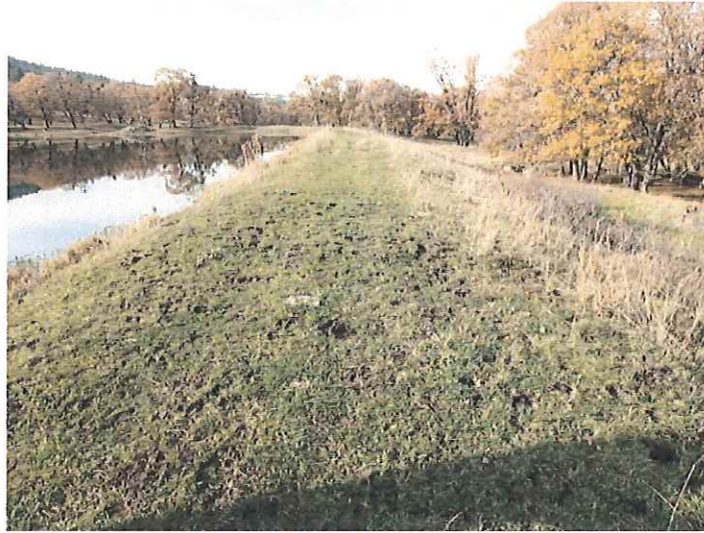
Cattle activity on the crest of the dam

There is abundant cattle activity along the crest and downslope of the dam. There is a clear pathway eroded on the downslope face that may promote erosion. Trampling of the crest can reduce freeboard and total storage of the reservoir. We recommended keeping cattle off the structure in the future in order to preserve its integrity in the long term. There are several small oak saplings along the down slope of the dam. These should be removed before they have the opportunity to compromise the structure.

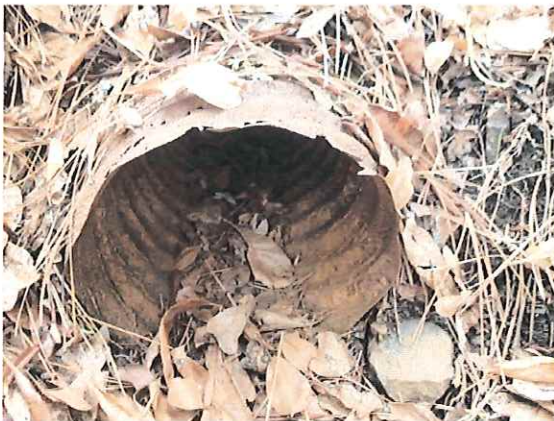
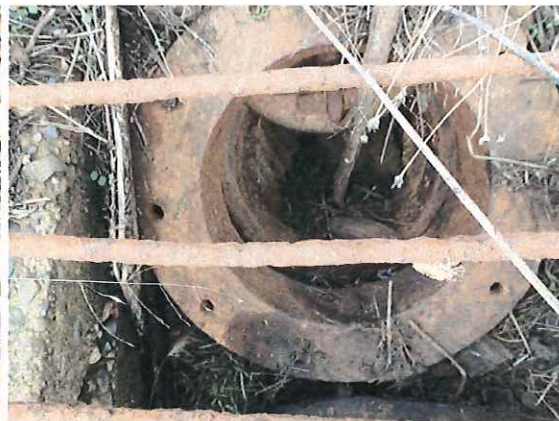
Outlet of low level conduit

Inlet to low level conduit

The inlets and outlet and control structure for the low level conduit are deteriorated with unclear functionality. We suggest cycling the outlet at least once per year to ensure the ability to release water in the event of an emergency.

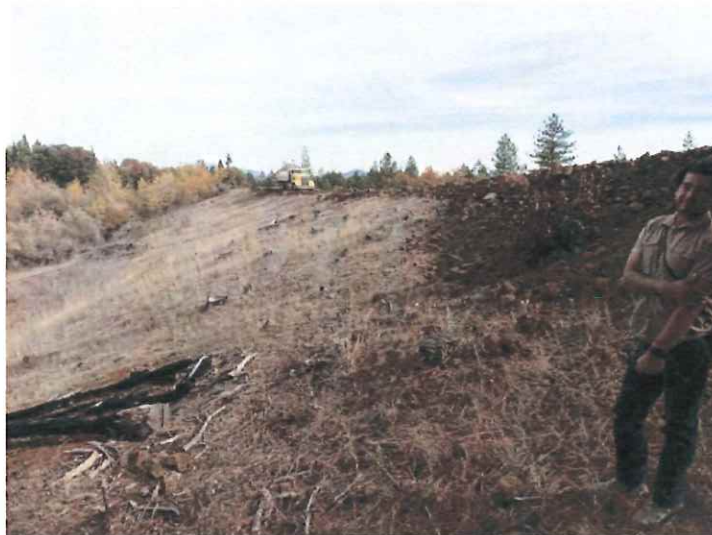
Road maintenance on the crest of the dam

This reservoir appears to not currently be in use. Please contact us if you put this dam back into service. We recommended that you continue regular on this structure in the interim.

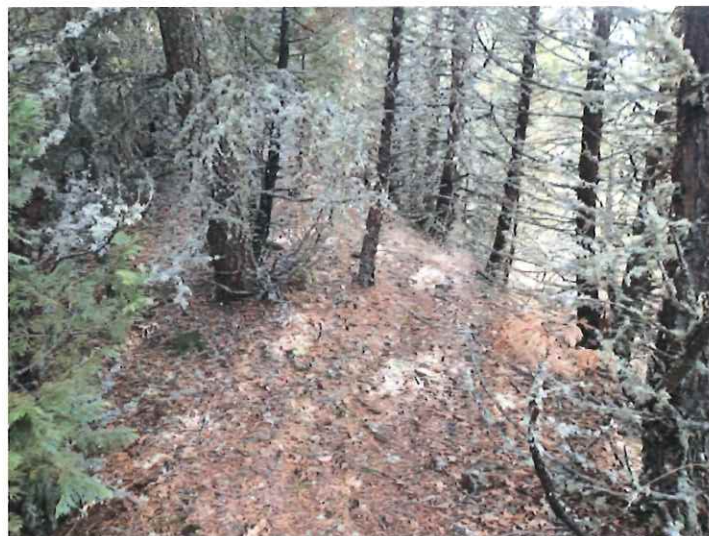
Numerous trees on auxiliary dam

While we were on site there appeared to be road improvement occurring along the crest of the dam. Any heavy equipment used may have lowered the crest and consequently the

available freeboard. Additionally, there was abundant vegetation growing along the left abutment, left auxiliary dike, and potentially within the channel of the spillway.

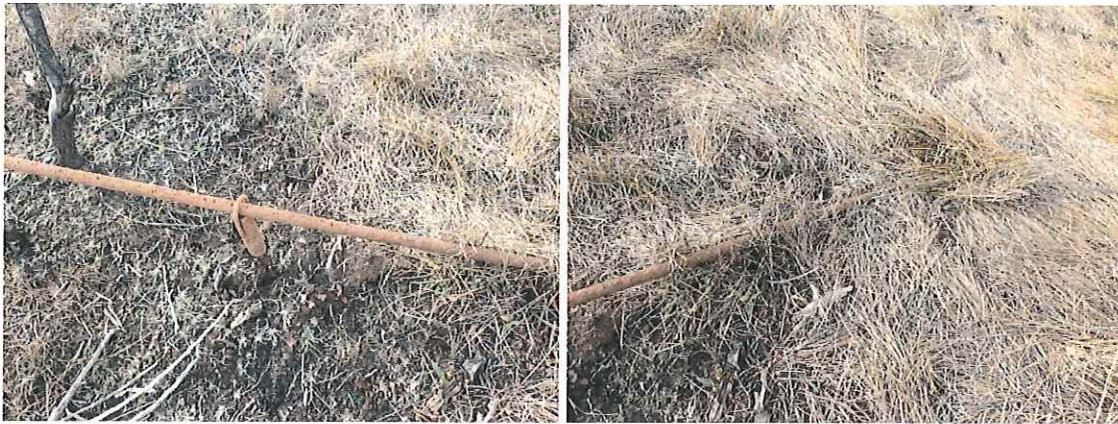
The control structures and outlet are corroded and partially buried. This may need to be addressed prior to resuming use of this reservoir. It is prudent the outlet be fully functional, as it is the only way to release water from the reservoir in the event of an emergency.
